Fire Research Report

Improving the Fire Performance of Polystyrene Insulated Panel in New Zealand

New Zealand Fire Service Commission Research Report Number 45

BRANZ Report No. FCR 9

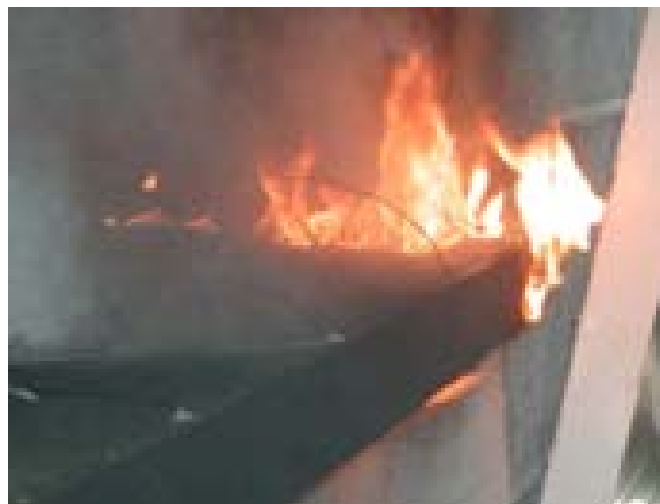
Figure 4.20: Trial 3 flaming on upper surface of specimen at 24 minutes.

Similar but smaller spikes in the smoke production were noted each time the burner output was increased. This was due to the greater area covered by the ceiling jet melting additional EPS, which either flowed into the burner flame or escaped from the edge capping and which burnt as shown in Figure 4.20.

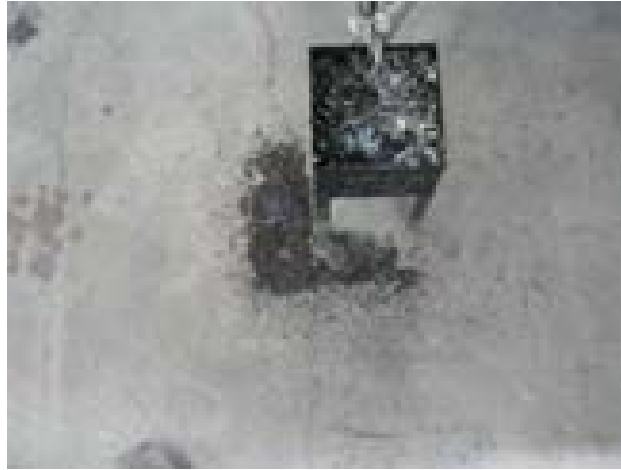
Figure 4.23: Trial 3 molten EPS had flowed from opening above burner and either burnt in the flame or deposited and solidified on floor.

The deposition of molten EPS that was not ignited in the burner below the cutout is shown in Figure 4.23.

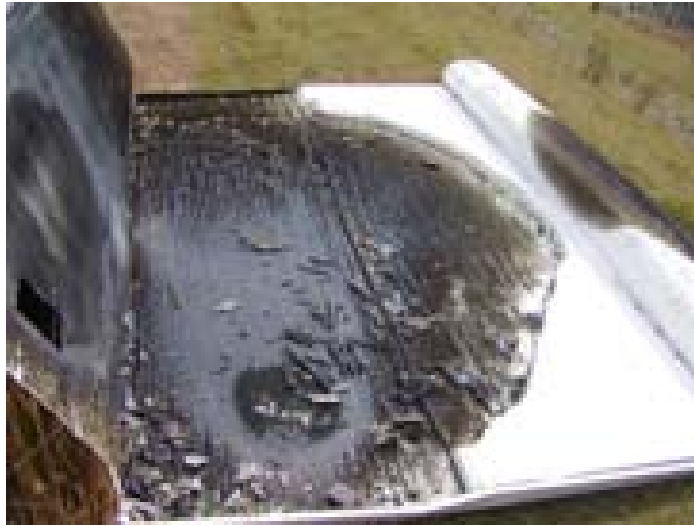
Figure 4.32: Remaining EPS core in trial 2.

For comparison purposes with the temperature contour maps and the percentage melted Figure 4.31, Figure 4.32, and Figure 4.33 show the remaining EPS when the panels were opened up for inspection. The remaining EPS matches that expected on the basis of the internal temperature measurements although the length of time the panel cores were exposed to the prevailing temperature could also be a factor accounting for some variation. It can clearly be concluded that fire spread within cavities is not self sustaining provided the joints remain intact.

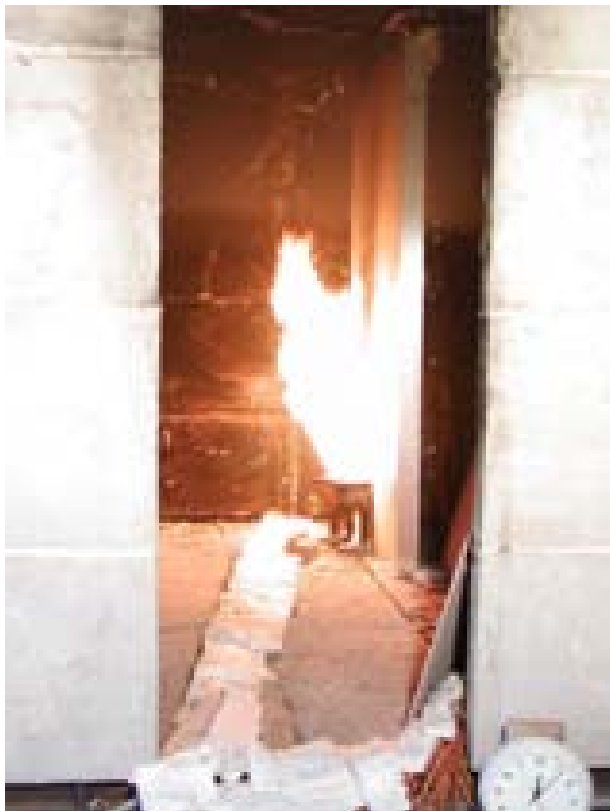
Figure 4.36: ISO9705 Room and joint 1 panel.

Each panel section was mounted inside 3600 x 2400 x 2400(h) mm ISO Room with a 2000(h) x 800 mm opening. In each trial, the joint was exposed to a propane burner at 100 kW for 10 minutes and then this was increased to 300 kW for a further 10 minutes (see Figure 4.36) in accordance with ISO 9705 (1993E) prescribed conditions. Fifteen thermocouples were installed at a nominal depth of 50 mm within the panel in a grid pattern at 600 mm centres covering the perimeter and the joint being evaluated.

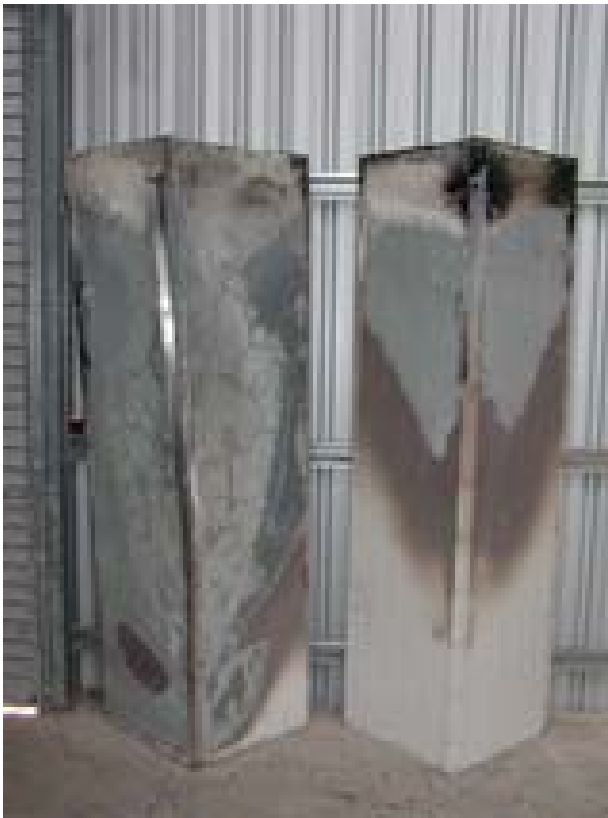
Figure 4.50: Corner joint specimens, unexposed side, trials 4 to 5 from left to right.

The samples were inspected externally for the extent of damage after the fire exposure and Figure 4.47, Figure 4.48, Figure 4.49, and Figure 4.50 show the flame affected surface, but the actual degree of opening of joints is unclear.

On the fire exposed side, the rivets securing the steel angle had either sheared or melted above a height of 1100 mm. On the unexposed side, the steel angle had detached, above 2000 mm height, by shearing or melting of the rivets. The edge capping had opened up only on the top edge, and had remained intact on each side.

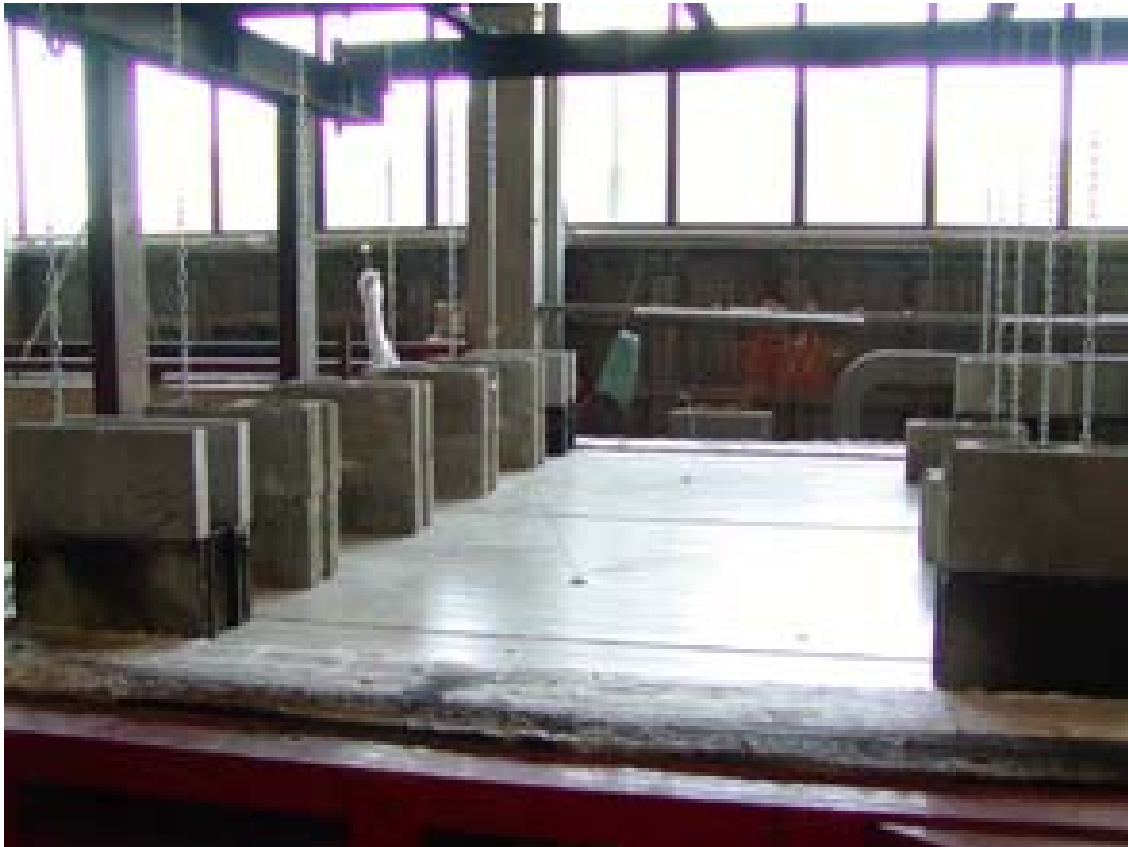
Figure 4.54: Suspended ceiling and weighted hangers on fire resistance furnace.

The ceilings in tests A and B were loaded to the equivalent of a 4.5 m span between hangers equivalent to a ceiling load of 0.12kPa, additional weight around hangers was added to compensate for reduced span limited by the 4000 mm long furnace. In test C, the weight at each hanger was increased to 64 kg to give an equivalent ceiling load of 0.24 kPa.

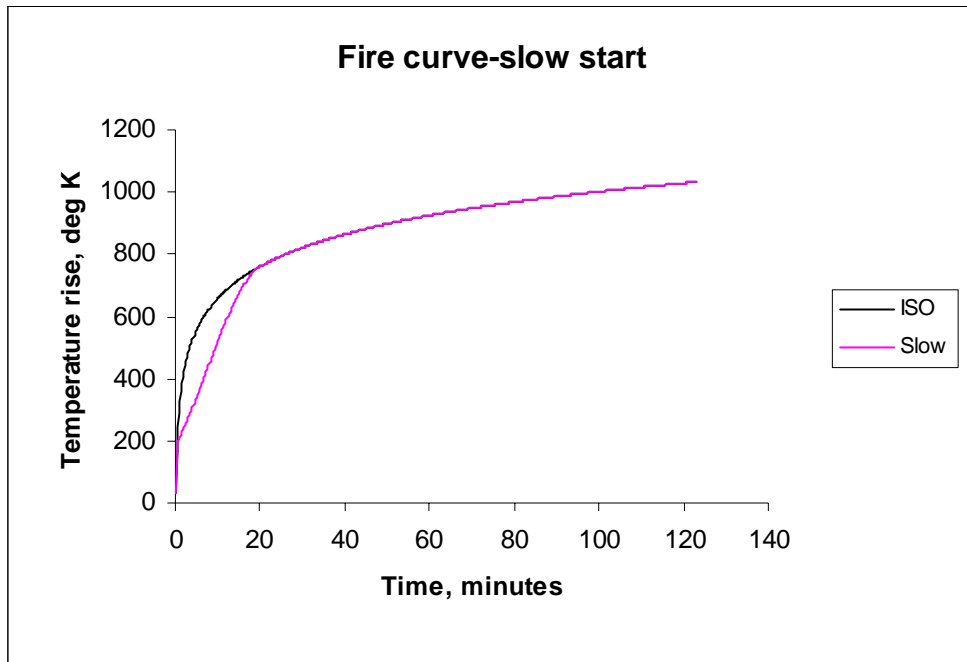
The standard time-temperature curve was modified to incorporate a slower start, so as not to damage and stress the panel adversely early in the test. This approach was also justified, as it is unlikely that a real fire in a large space would grow that quickly. The slow start only equated to a 3 minute delay in time-temperature curve beyond 20 minutes compared with the ISO curve. So in the case of test C the test was run for 123 minutes and this is equivalent to 120 minutes to the standard conditions. The modified time-temperature curve is shown in Figure 4.55.

Figure 4.55: Modified time-temperature curve used in suspended ceiling tests.

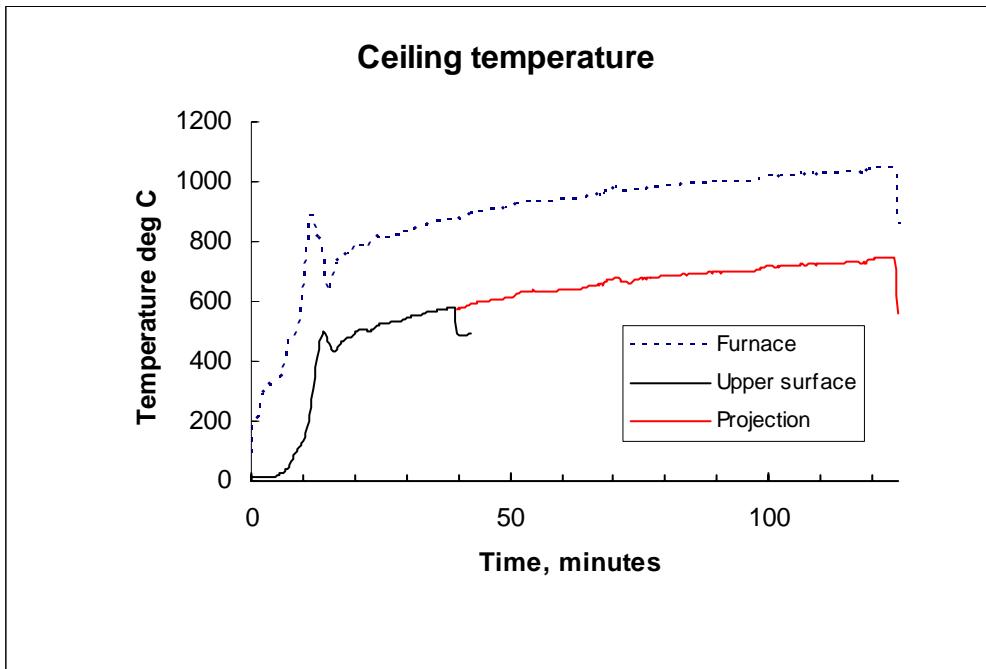
Figure 4.56 shows the ceiling temperature on the upper surface of the ceiling and in the furnace. The temperature spike between 11 to 15 minutes is due to the involvement of the EPS core and the subsequent trough is after it had been consumed and the furnace burners restarted. Recording of the upper surface temperature was only possible to approximately 40 minutes when the thermocouple became detached from the surface, at that time the surface temperature was lagging behind the furnace temperature by approximately 300°C and the projection beyond 40 minutes is based on that. After 120 minutes, it is estimated the upper steel skin of the panel was at 700 to 750°C and the lower skin appreciably more, without any structural failure.

Figure 4.56: Typical temperature of ceiling and furnace.

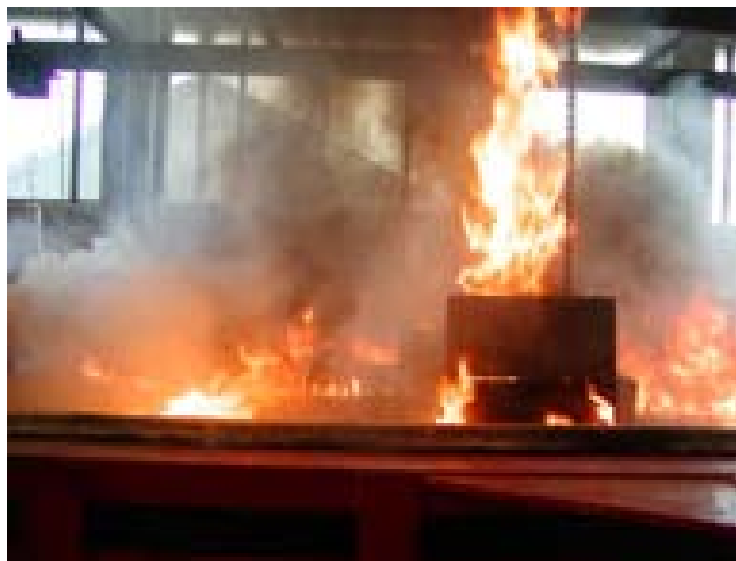
Figure 4.57: Suspended ceiling test showing flaming between 11 and 15 minutes.

Significant milestones in the tests were the melting of the plastic caps at 6 minutes, the involvement of the EPS core between 11 and 15 minutes (see Figure 4.57) requiring the furnace to be turned off to prevent a temperature overrun. Progressive opening of joints occurred from 30 minutes to 70 minutes and then some deformation (cupping) of the ceiling panel over the suspension nuts and washers. Not a single failure or pull through of a suspension point was noted or appeared likely to happen, even if the tests had continued (see Figure 4.58 and Figure 4.59). The ceilings had reached a stable condition and appeared likely to have remained attached beyond the 120 minutes of test C.

Further consideration needs to be given to what fire load or duration is likely in a ceiling space. In the furnace ceiling tests there was observed to be about 3 minutes of intense flaming (between 11 and 14 minutes into the tests) on the upper surface as the fuel load in the 100 mm thick panel burnt off, after that there was no further flaming on the upper surface. By establishing the likely fire exposure in a ceiling space for actual buildings it is very likely that this will be equivalent to less than 30 minutes exposure to an ISO standard time-temperature curve fire.

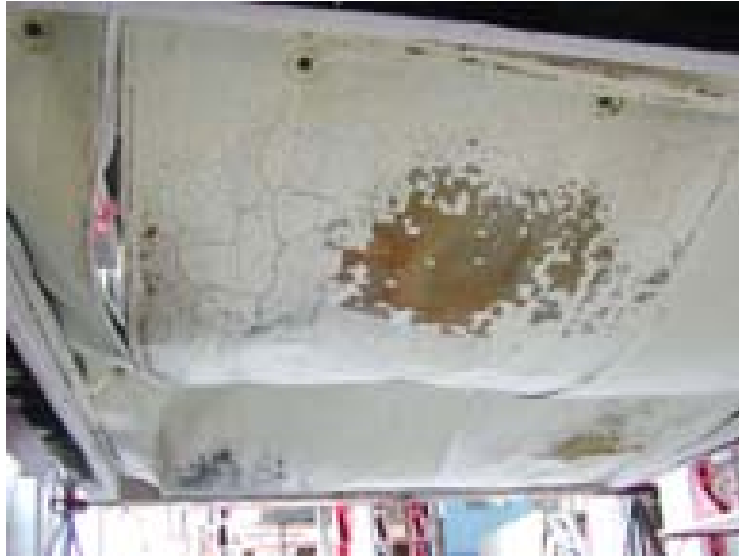
Figure 4.58: Suspended ceiling after test.
